PS#KVPB03KIT
SSD#107-6034

For EZ Rebuild Kits Or Tech Support, Contact 1-800-SCORE-OK or Visit www.ScoreDental.com

Kavo 625 CD* Push Button

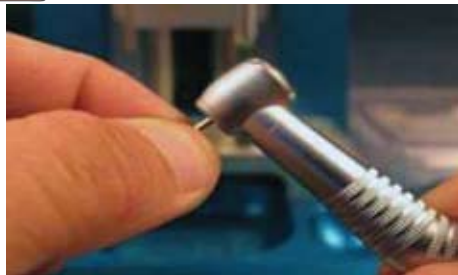
Step 1
Before starting, review the training video and step-by-step instruction sheet. Install the blank bur provided with your EZ Press. To ensure the spindle is holding the bur, tap the bur against the counter and try to remove it using your fingers. If bur pulls out contact Score for a replacement spindle.

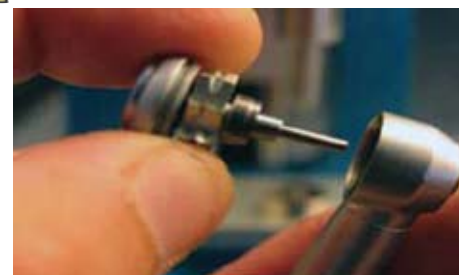
Step 2
Loosen headcap using cap wrench and remove turbine. If headcap and turbine come out together, separate and set headcap aside

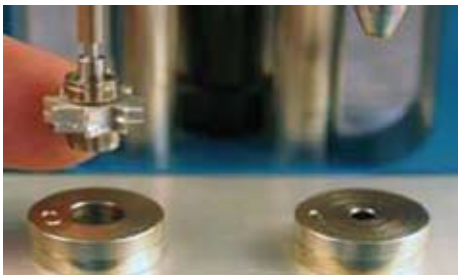
Step 3
Place Insert C underneath the Spindle Ram on the left side of the press. Pick up the turbine and feed the blank bur up into the Spindle Ram. While holding the turbine in place slowly pull down on the handle until the rear bearing goes down into the hole in Insert C and the impeller is lying flat on its' surface

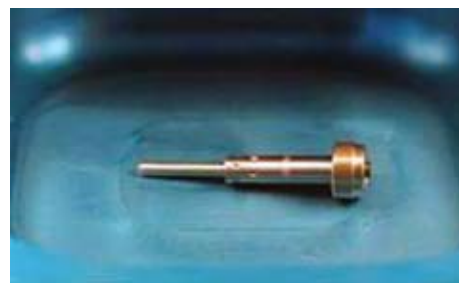
Step 4
Once the turbine is aligned pull down firmly on the handle. The spindle with the rear bearing still attached will be pressed out and fall into the tray below. The impeller and old front bearing will remain sitting on Insert C.

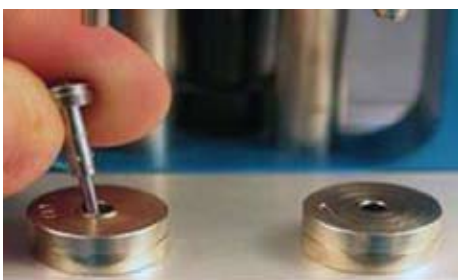
Step 5
Remove Insert C along with the parts that were pressed off and install Insert B on the left side. Retrieve your spindle and rear bearing and place in the center of Insert B with the bur going down through the hole in the center. The rear bearing will catch on the insert and prevent the spindle from falling through.

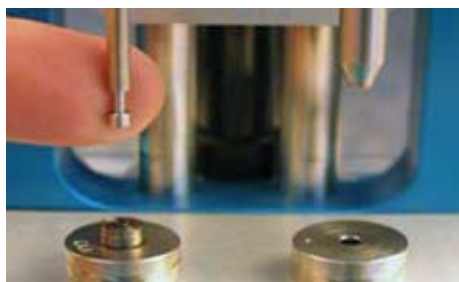
Step 6
Locate the EZ Push Button Protector that was included with your EZ Press. Feed the skinny end up into the spindle ram on the left side of the press and hold in place. Slowly pull the handle down until the protector meets the rear of the spindle and covers the button.

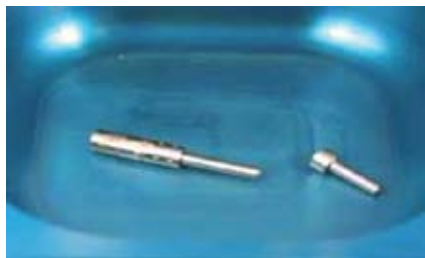
Step 7
Verify all parts are aligned and pull down or tap on the handle firmly to push the rear bearing off of the spindle. The spindle and protector will fall down into the tray below. Now the turbine is completely disassembled.

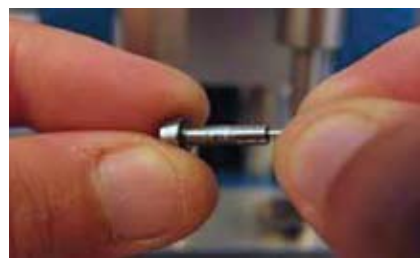
Step 8
Discard both old bearings and inspect the impeller for any damage. If any damage is detected call Score for replacements. Open your new rebuild kit, pick up one of the bearings and try to get it started on the rear of the spindle with your fingers. The black side of the bearing should face bur end. If the bearing is loose enough to push all of the way on with just your fingers use EZ Tight to hold it on.

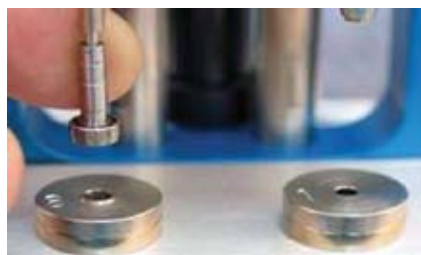
**Step 9**
Feed the blank bur up into the spindle ram on the left once more and hold in place. Slowly pull the handle down until the rear bearing meets Insert B. Make sure everything is aligned and gently press the rear bearing onto the spindle. You will feel the bearing come to a stop because the spindle is stepped in the center. **DO NOT FORCE PAST THIS POINT WHEN YOU MEET RESISTANCE! (WARNING)**

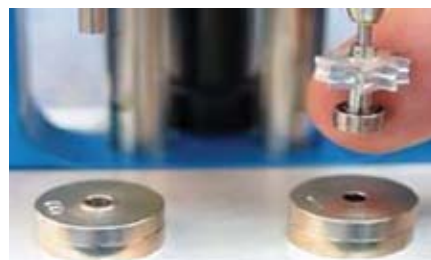
Step 10
Locate Insert #1 and place underneath the bearing ram on the right side of the press. Locate your impeller and pick up your spindle that you just pressed the rear bearing onto. Hold the spindle so the bur points up and drop the impeller over the bur. Before pressing the impeller on check the direction. With the bur pointing directly away from you the blades at the 12 o'clock position should be slanting to the left. If slant is correct feed the bur up into the bearing ram on the right and hold in place. Slowly pull the handle down until the rear bearing meets Insert #1. Verify the end of the spindle is aligned with the hole in the center of Insert #1, then press the impeller down until it comes to a stop. If the impeller is riding loosely on the spindle call Score for replacement

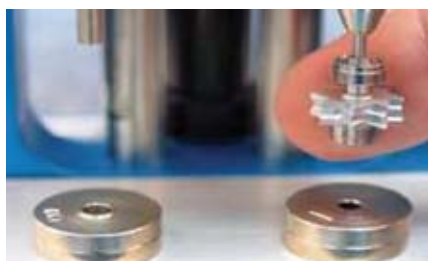
Step 11
Locate the front bearing and drop it over the bur. The black side of the bearing should face down towards the impeller. Verify alignment. Repeat the pressing procedure. If the front bearing is riding loosely on the spindle use EZ Tight to hold it on

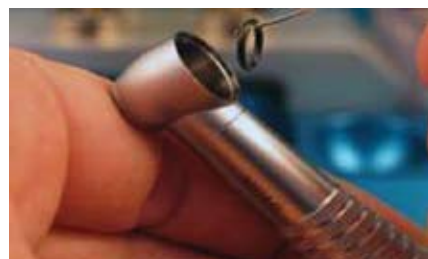
Step 12
Using an explorer and a cotton swab with alcohol or handpiece cleaner, remove the old o-rings from both the headcap and head of the handpiece, inspect both for debris and remove if present and clean thoroughly. If any debris is overlooked the turbine may not fit back into either the headcap or head and may bind if it does. Install the new o-rings from the rebuild kit into the headcap and head of the handpiece. Now seat the rebuilt turbine into the headcap and install into handpiece. Make sure that the bur releases and the turbine rotates inside of the head.

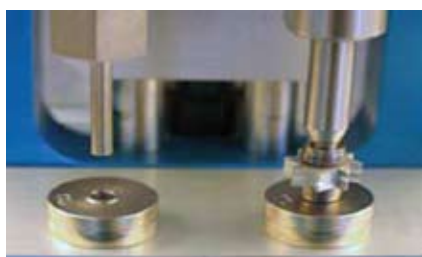
Step 13
13. If turbine is binding even though all debris has been removed or the headcap heats up while running, remove the turbine from the handpiece and remove Insert #1 from the right side of the press. Locate and install Insert #3 in its' place, feed the blank bur up into the Bearing Ram and hold as you repeat the pressing procedure until you feel a slight shift of the parts. Once you feel a shift re-install turbine and test.
